PROJECT: Midnite Mine Remediation**REPORT NO:** 2021-19**OWNER:** Newmont/Dawn Mining**OPERATOR:** Newmont/Dawn Mining

This weekly report provides a summary of Midnite Mine Site (Site) remediation action (RA) construction activities, quality assurance (CQA), quality control (CQC) and engineering activities for the period July 30 – August 5, 2021. The Site activities discussed in this weekly report include, but are not limited to: Site Health, Safety, and Security; Community Liaison, Project Meetings, Regulatory Oversight, Site Visitors; Site Mobilization; RA Activities; Project Documentation; and Site Inspections.

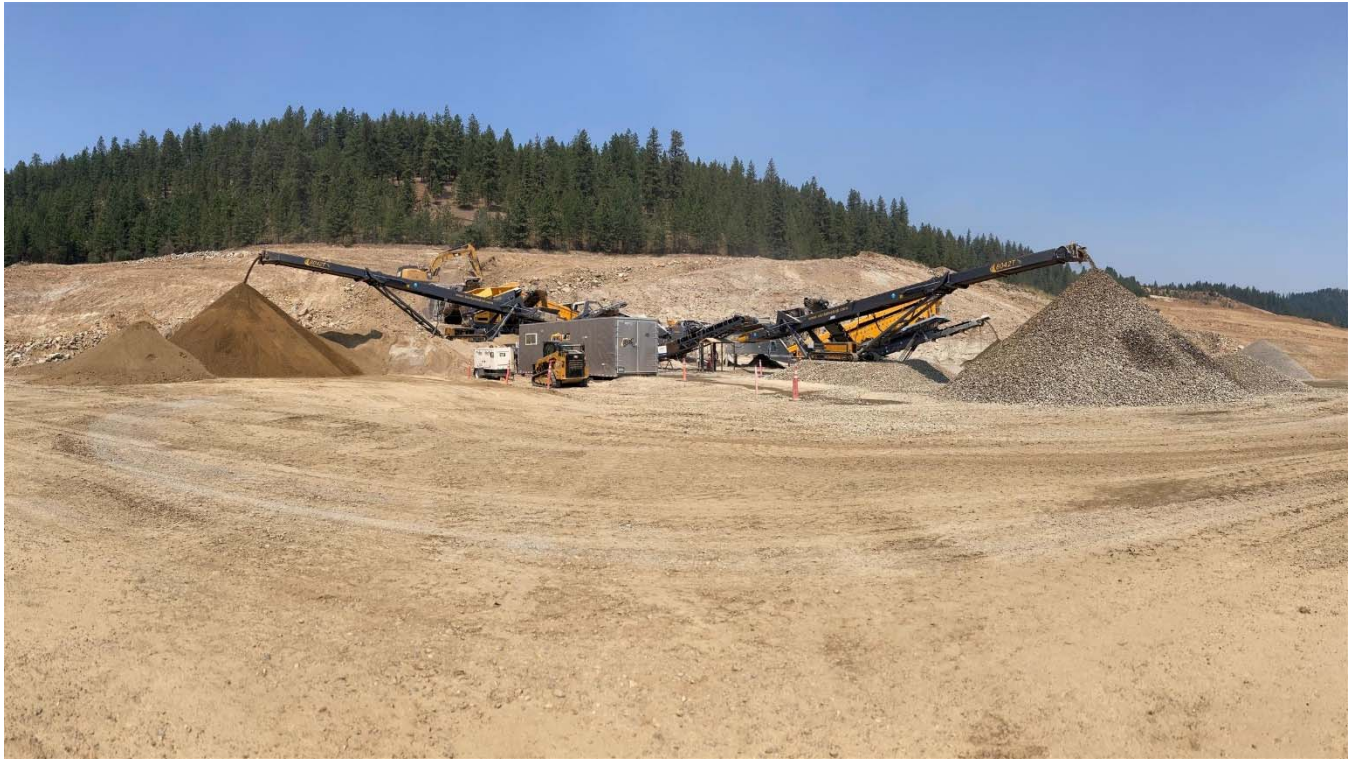
Figure 1 – Crushing and screening operations at the HSWRP, view looking northeast.

- SLV Earthmovers continued crushing and screening material from the Hillside Waste Rock Pile (HSWRP) to produce Drain Gravel and Geomembrane Bedding Material. Newmont hauled these materials to stockpile locations designated in the 2021 Crushing and Stockpiling Work Plan (Stantec, 2021). Estimated quantities of materials produced are presented in Table 1.

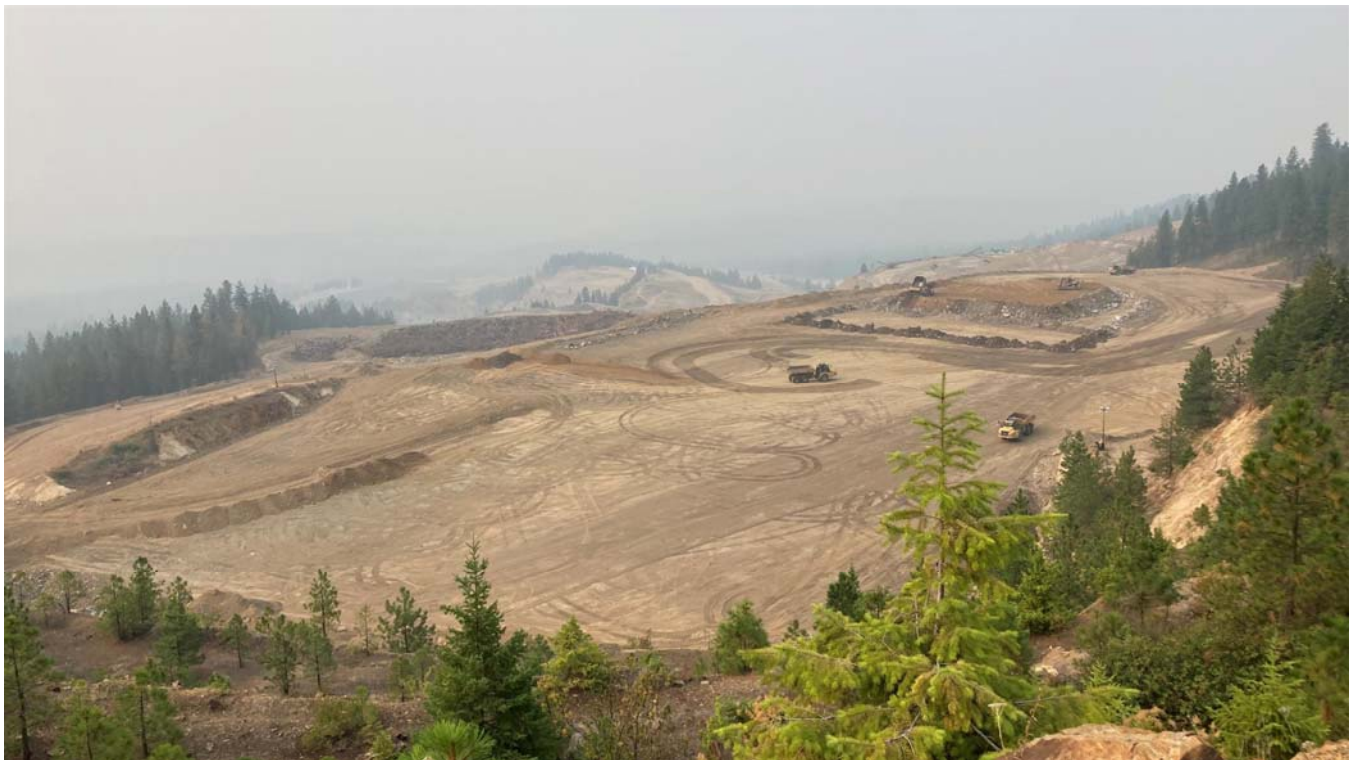
Figure 2 – Placement of low activity/low reactivity material into Pit 4 as required, view looking south.

- Newmont excavated, hauled and placed low activity/low reactivity material from the west side of the South Waste Rock Pile (SWRP) and the Pit 4 Overburden Pile. Newmont placed these materials in the Pit 4 Waste Containment Area (WCA).

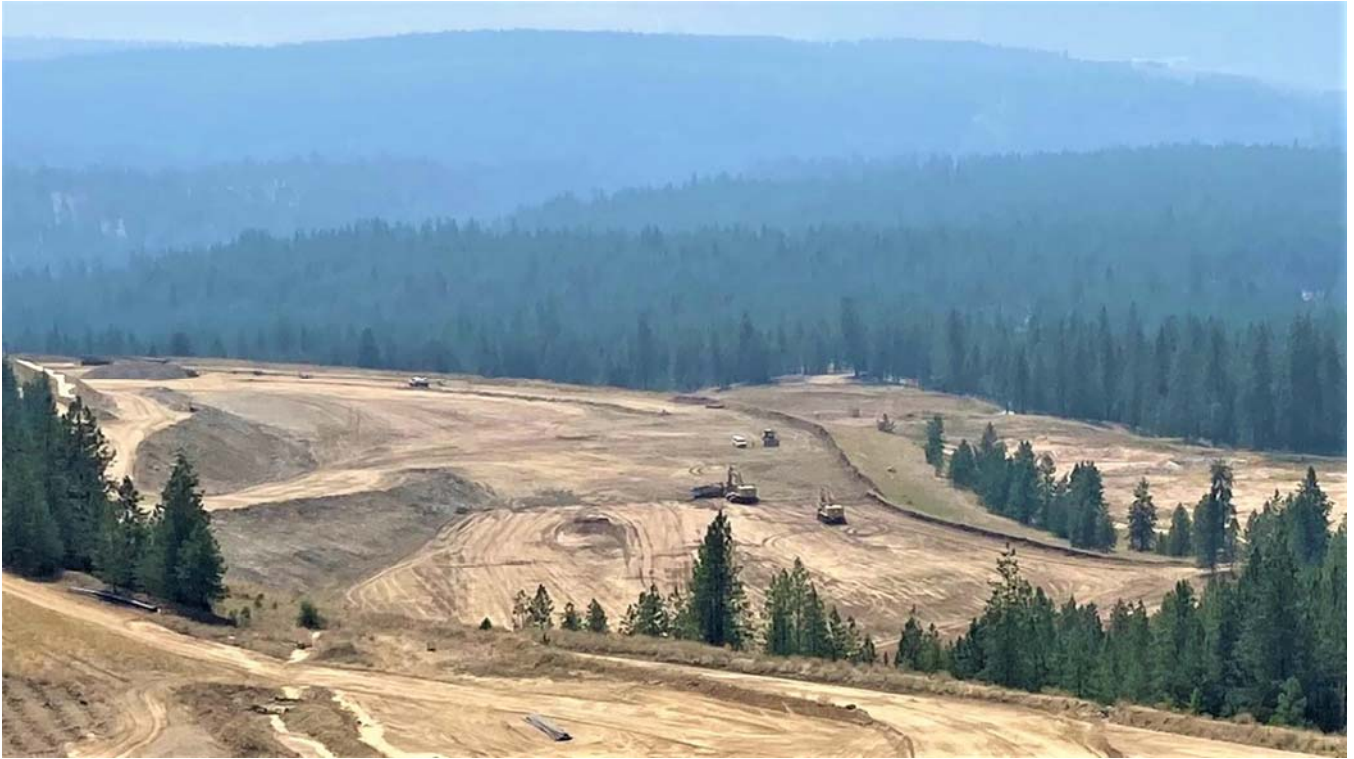
Figure 3 – Excavation, loading and hauling of material from the South Waste Rock Pile – Mid loadout 2, view looking southwest.

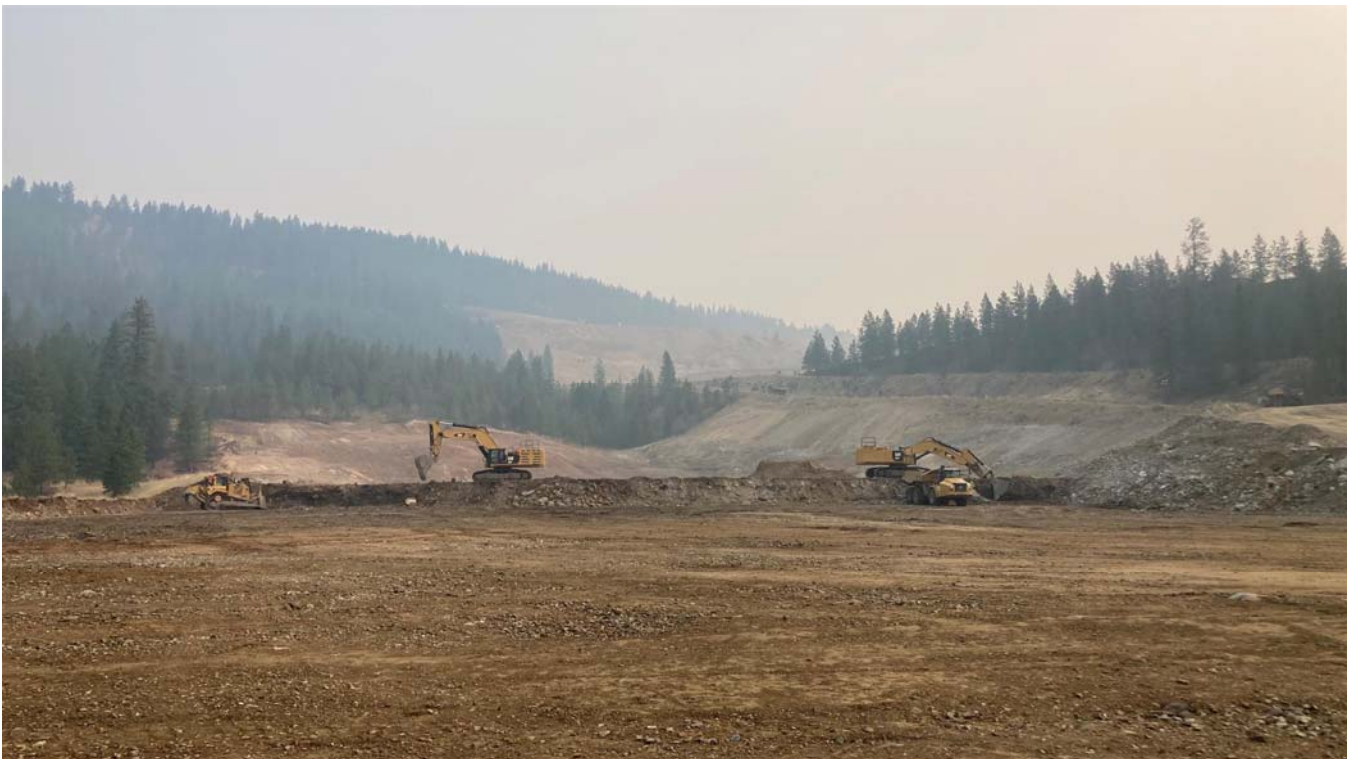
Figure 4 – Excavation, loading and hauling of material from the South Waste Rock Pile – Mid loadout 2, view looking northeast.

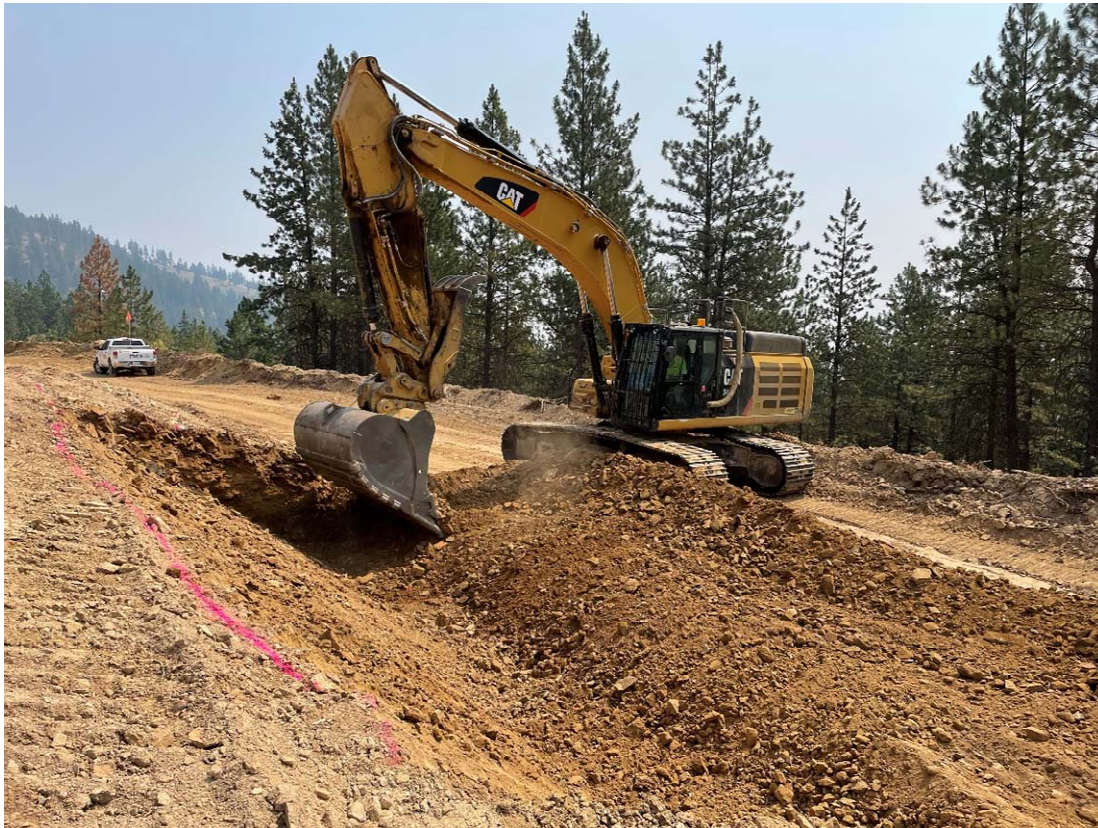
Figure 5 – Drainage ditch excavation in along East edge of Pit 4 Overburden.

- Newmont continued to excavate the Pit 4 Overburden Middle stormwater channel.

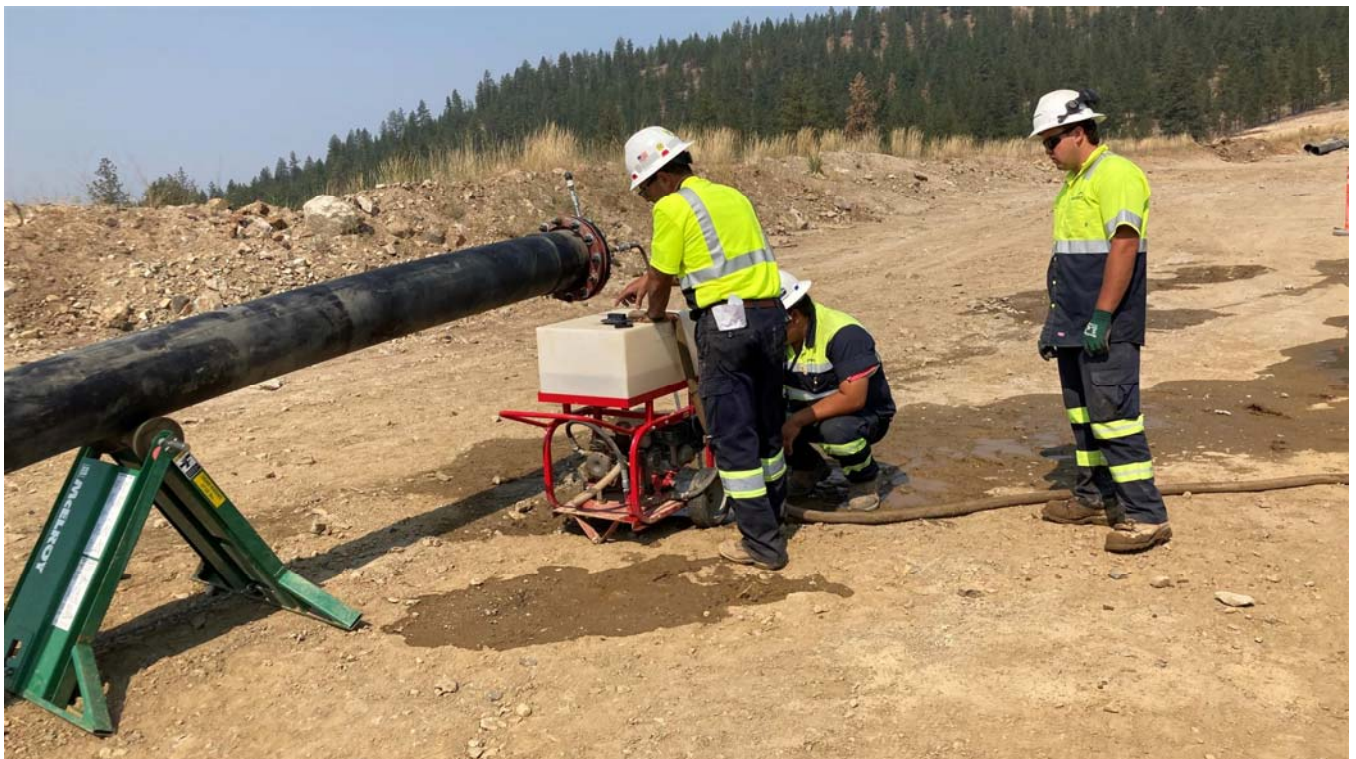
Figure 6 – Pressurizing the 10" HDPE pipe for hydrostatic testing.

- Newmont pressure tested the 10-inch HDPE Pit 3 Dewatering Pipeline and moved the pipeline into Pit 3.
- Stantec performed Method 9 visible emissions observations at the crushing and screening operation on the HSWRP on 30 July. Visible dust from the crushing operation conformed with project requirements.
